SUBJ: SIGNIFICANT INCIDENT REPORT - INITIAL

SUBJ: COLLISION HMCS PRESERVER - INITIAL REPORT

HULL SURVEY SHEET FOR		DISTRIBUTION LIST	
HMCS Preserver		CDTL - original copy	
COMPONENT STRUCTURE		ENG/NAO/Hull Survey Office - file copy	
		LOCATION	FORE PEAK
		Fore Peak - FR10	01, 1
		FRAME	DECK
			STBD SIDE
JUSTIFICATION FOR SURVEY			
1. Survey and prepare repair instructions for damage to bow.			
REF: FMFCS Job No. 820161471		REF DWG NO.: 509-H26-21228, 509-H26-21234, 509-H26-21237	
DESCRIPTION OF WORK REQUIRED

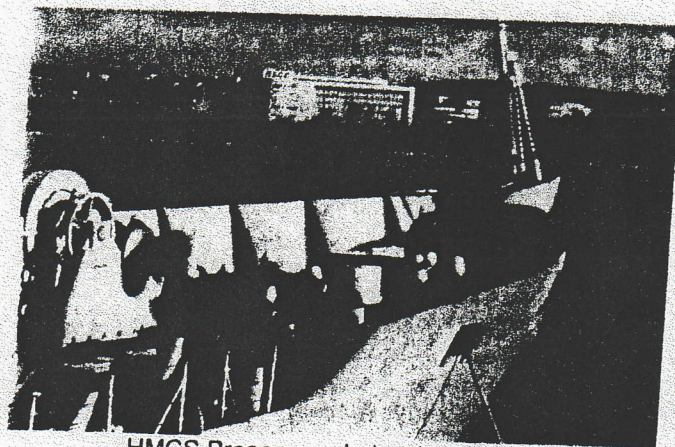
1. A structural survey to investigate collision damage to the bow of HMCS Preserver was conducted on November 7 to 11, 2011 by DEA Hull Surveyors with the following results.
2. The Bulwarks on STARBOARD side are bent and distorted, including all bulwark stanchions from Frame 10 to bow, and also distortion to forward bulwarks on Port side, with two stanchions exhibiting damage. The plating on 01 Deck is exhibiting local deformation where all bulwark stanchions are attached. There is some deformation to the shear strake on STBD side forward of Frame 10, and also shell is holed at 1 Deck Frame E.

HMCS Preserver - bulwark damage.

3. The following are the repairs for the bulwarks:
 - a. Crop and remove eight (8) bulwark stanchions from Stbd Frame 10 to Port Frame J (one bulwark from bow) including landing and flat.
 - b. Fabricate and install all new bulwark stanchions in way of removals. Pattern can be taken from port side. Also refer to reference drawings and removed sections. Allow additional material (1.5") on bottom end of new bulwarks to facilitate fitting to original locations that now exhibit acceptable deformation in 01 Deck plating.

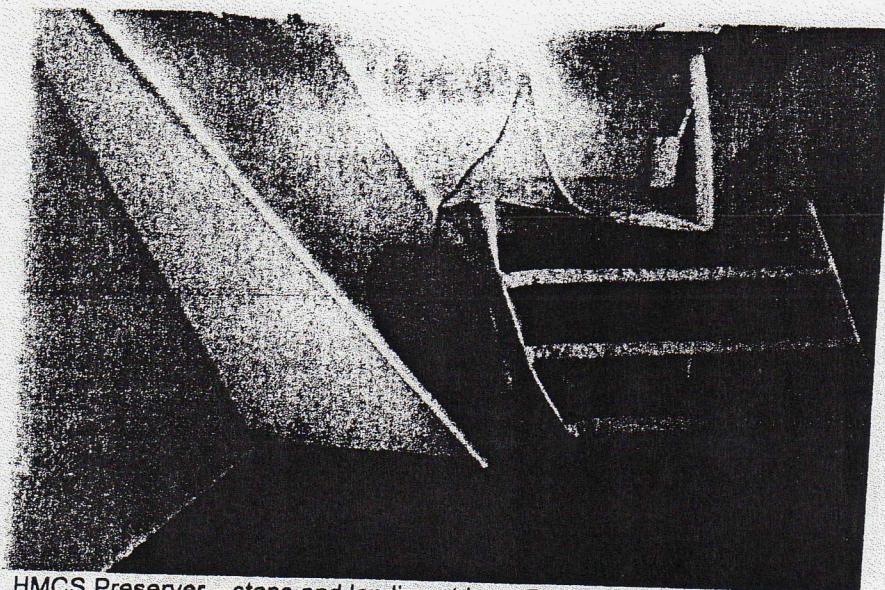
- d. Port side bulwark stanchion located at Frame J (torn away from deck plating). Scale area in way of broken weld and conduct MT NDE testing to capture full extent for fracture. Remove the weld fracture from one (1) side by grinding/gouging no more than 75% of base metal and prepared for welding. Bulwark to be faired from existing position to correct any side deflection that exists, and returned to its original shape. Weld stanchion to 01 deck from one side once bulwark position has been corrected and confirmed. Repeat the weld procedure from the opposite side to ensure a complete joint penetration weld upon completion. All prepared areas are to be 100% examined using MT NDE to ensure fracture is completely removed, fill excavated areas with steel weld until a full 1/4" fillet is achieved. Affected areas are to be 100% inspected using visual and MT NDE methods of inspection a minimum of 24 hours upon completion of weld repairs. Note: Repairs to underlying deck beam are to be completed prior to these bulwark repairs.

- 4. Bow Platform and steps located at bow of ship is bent and distorted. Fabricate new as per original configuration.

HMCS Preserver - steps and landing at bow, Port side bulwark stanchion.

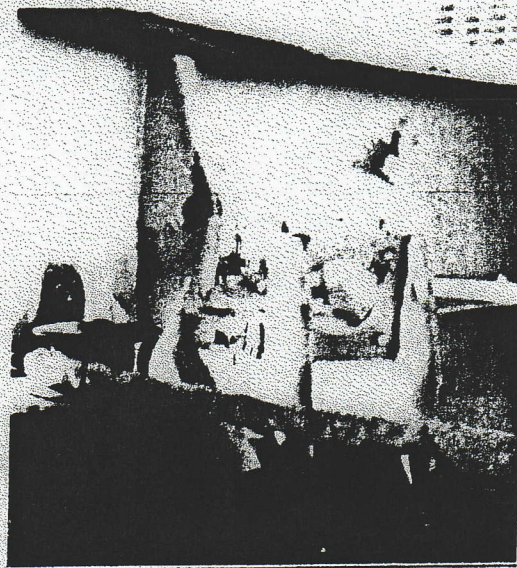
5. The mounting structure for the anchor catting fairlead is damaged and distorted, with the fairlead block sheared off at bolts. Fabricate, fit and install catting fairlead as per existing. Pattern can be taken from existing mount on port side. Drawing 509-H26-21237 Sheet 2 refers to Plan No. 204/1.

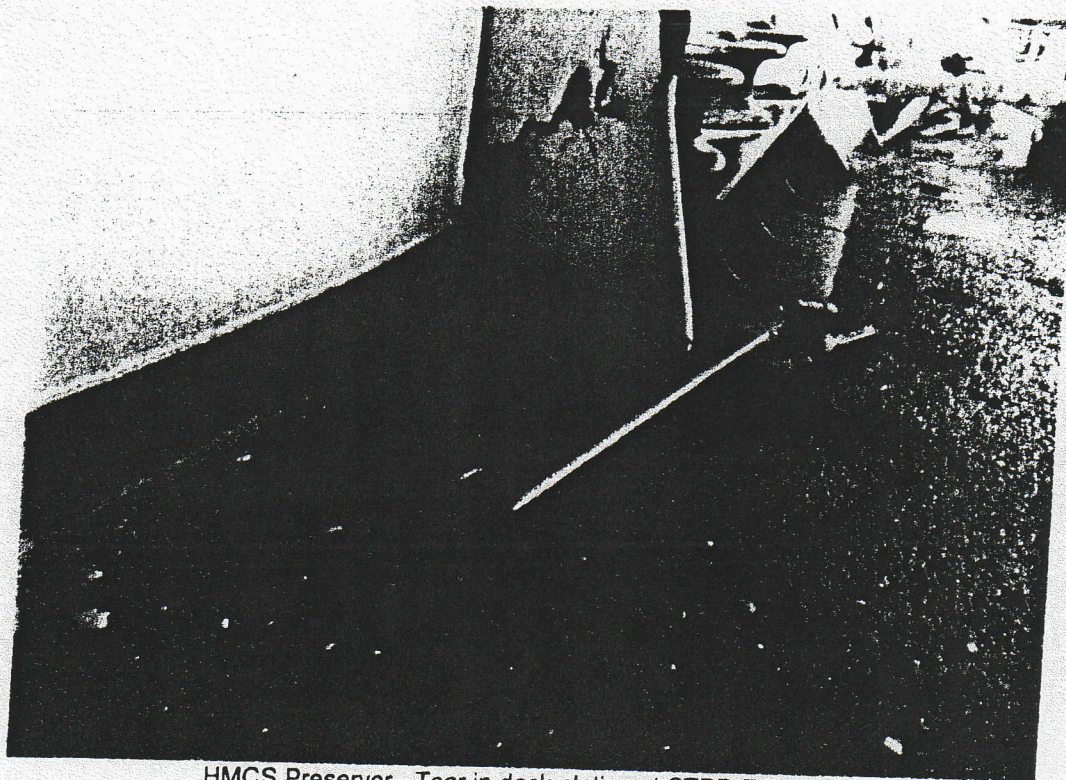
6. The deck plating on 01 Deck, at Frame 0, STBD side is torn, exhibiting an opening to Bos'n Workshop located below. Crop and remove section of deck plating beginning at 3" forward of Frame A to 24" Aft (3" aft of Frame 0), from ship side inboard a distance of 36" at Frame 0, ensuring that full extent of torn deck plating has been removed through NDE inspection. If insert size increase is required, contact Hull Surveyor to determine additional work required. Supply, fit and install new section of deck plating as per sketch.

HMCS Preserver - Tear in deck plating at STBD Frame 0

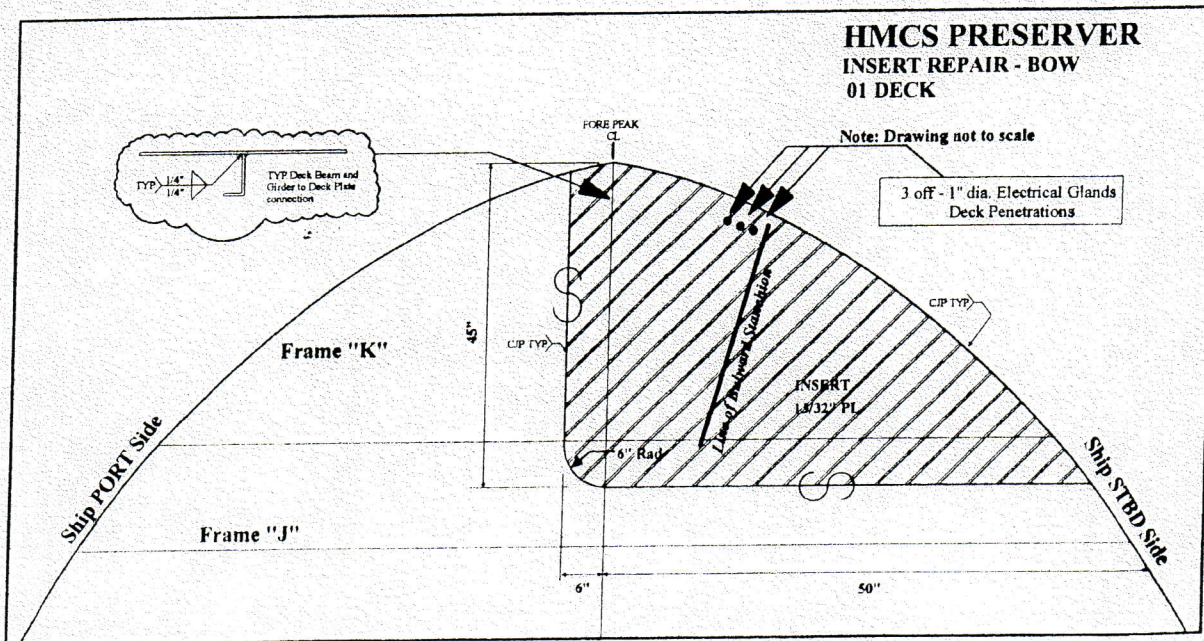
8. The deck plating on 01 Deck, at Forward peak of bow back to aft of Frame "J" is exhibiting deformation on starboard side in way of bulwark stanchion attachment location. Insert in deck plating required. Crop and remove section of deck plating beginning at forwardmost of bow to 45" Aft (3" aft of Frame station K), from ship side inboard a distance to 56", ending 6" to port side of centerline girder. Supply, fit and install new section of deck plating as per sketch. Supply, fit and install three (3) electrical glands as per existing arrangement.

NOTE : Weld joint of deck plating to shell plating is a to have a prepared edge on the deck plating to give a Complete Joint Penetration weld, and not to be double fillet weld.

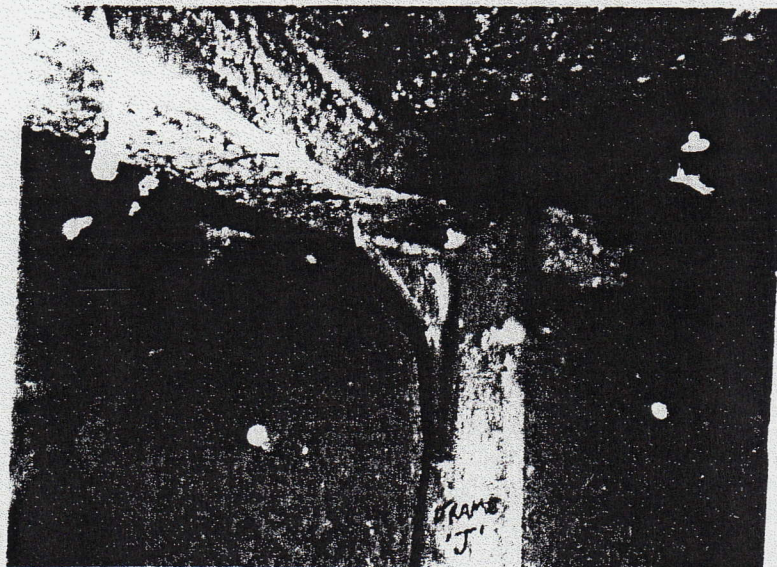
9. The deck beams and brackets connecting 01 DECK beams to STARBOARD side frames are "tripped" and distorted in the following locations:
- a. STBD - Frame 10
 - b. STBD - Frame 7
 - c. STBD - Frame 0
 - d. STBD - Frame E
 - e. STBD - Frame F
 - f. PORT - Frame F
 - g. STBD/PORT at Frame J - this deck beam tripped on both ends and in middle. Full replacement of deck beam required, complete with two (2) brackets. Deck beam may be installed in two pieces with one butt joint off centre at 30 degree angle.

HMCS Preserver - Deck beam and bracket distortion.

- h. Repair tripped deck beams by cropping distorted sections and replace with new steel shape, and fabricate and install new brackets. See attached sketch.

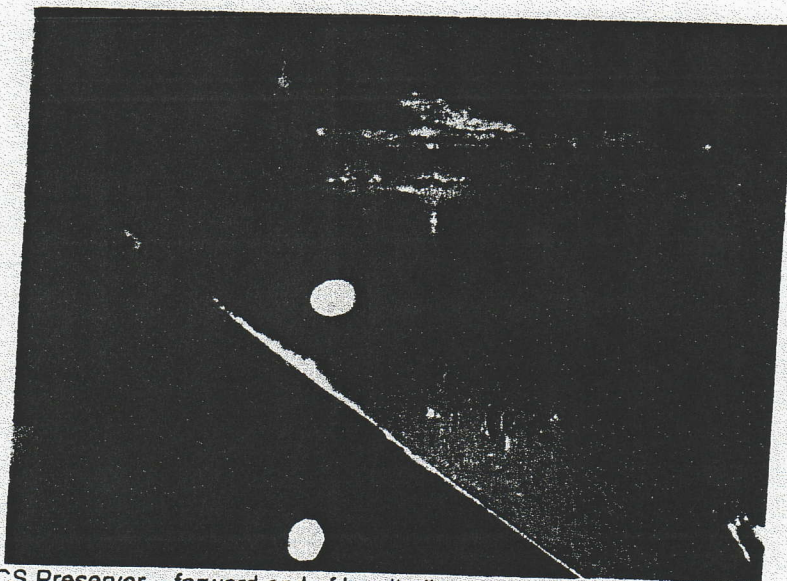
10. The longitudinal girder located Starboard side underneath 01 Deck is exhibiting fractures in the welded joint to 01 Deck in way of Frame "D". Scale area of weld, both sides to determine extent of fractures. Remove the weld fracture from one (1) side by gouging no more than 75% of base metal and prepared for welding. If the fracture completely penetrates to the opposite side, repeat this procedure from the opposite side to ensure a complete joint penetration weld upon completion. All prepared areas are to be 100% examined using MT NDE to ensure fracture is completely removed, and fill excavated areas with steel weld until a full 5/32" fillet is achieved. Affected areas are to be 100% inspected using visual and MPI methods of inspection a minimum of 24 hours upon completion of weld repairs.

HMCS Preserver - forward end of longitudinal girder 01 Deck Stbd Frame D.
